H.P. WHITE LABORATORY, INC.

March 13, 2008
[HPWLI 10684-01A]

REPORT OF ANALYSIS

Sample of Black Powder Muzzle Loader

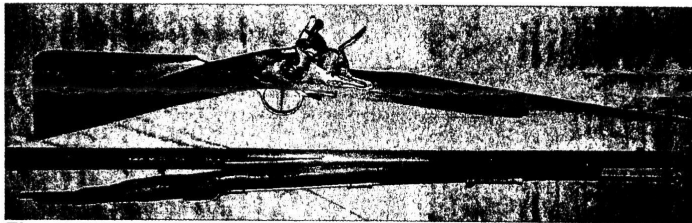
The rifle was severely damaged. The buttstock and a portion of the forearm still retain the entire lock mechanism. The barrel, ramrod and a large portion of the forearm are separate. The barrel has stampings to indicate it was fabricated in India. The barrel is split at the rear to about 50 cm forward of the breech end. The area in which the fracture originated appears to be bulged slightly. A bulge is usually the result of an obstruction in the barrel. There is also a deposit of unknown grayish residue in the barrel not at all typical black powder residue.

A damaged Brown Bess Pattern Musket was received from H.P. White. The rifle as received is shown in figure 1. There are three main pieces: the buttstock with lock mechanism attached with a portion of the forearm still attached, the rifle barrel with a portion of the split forearm attached and a small splinter of the forearm (not shown).

Figure 1 As received Brown Bess Musket

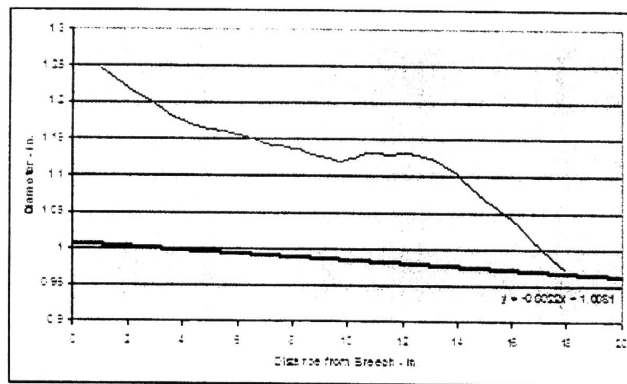
Figure 3 is a graph of the diameter of the barrel as a function of the distance from the breech. At a distance of roughly 12 inches from the muzzle, there is a significant hump or bulge in the plot. This is where the maximum pressure that the barrel could sustain was exceeded.

Figure 3 Barrel profile from Breech to muzzle

In summary, to a high degree of scientific certainty, no connection could be made to the material or micro structures contained in the rifle barrel as the source of failure. The location of the failure, approximately 12 inches from the breech, suggests a barrel obstruction of some sort.
