Project 1: Improving thermal performance of high-density amplification and audio processing.

Project 2: Electrostatic loudspeaker development – towards a “bulletproof” ESL speaker.

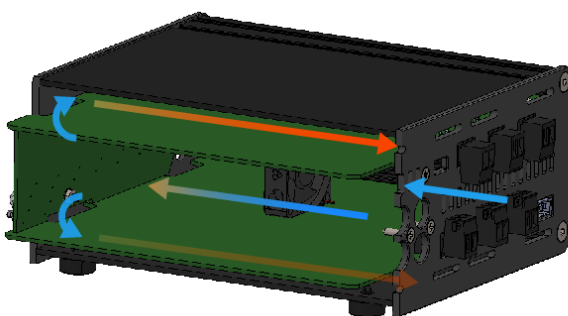
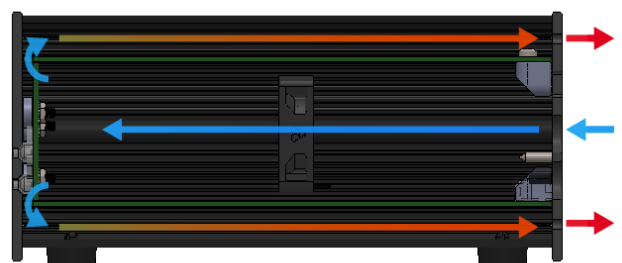
Airflow Path with forced convection

- All PCBs were redesigned to give a continuous airflow path past all components and interface with the vents in the rear plate (Pictures here)
- Allowance was made for the option of a small fan to be installed in the Amp Master to provide the addition of forced convection. This was intended as a last resort as most small fans, even at their lowest speed, create motor noise and air turbulence that will generate noise as it passes through vents.
- Having vents created an acoustic resonance in the box, further exacerbating any potential fan noise.
- After testing, it was found forced convection was not required, but the option has been retained for potential future design updates.

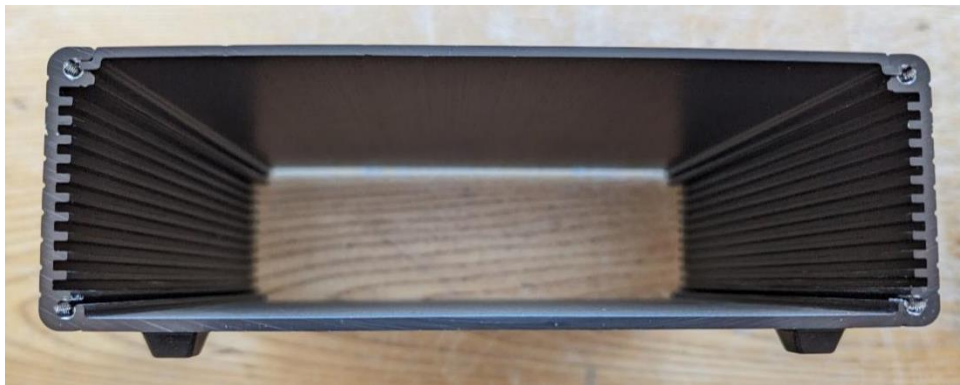
Original case (Off the shelf extrusion, low quality control) – This case was used for both the Surround Master and the Amp master initially.

The original case design was an off-the-shelf extrusion with custom-made end plates. This was originally thought to be more than adequate for heat dispersion but time and testing showed otherwise.

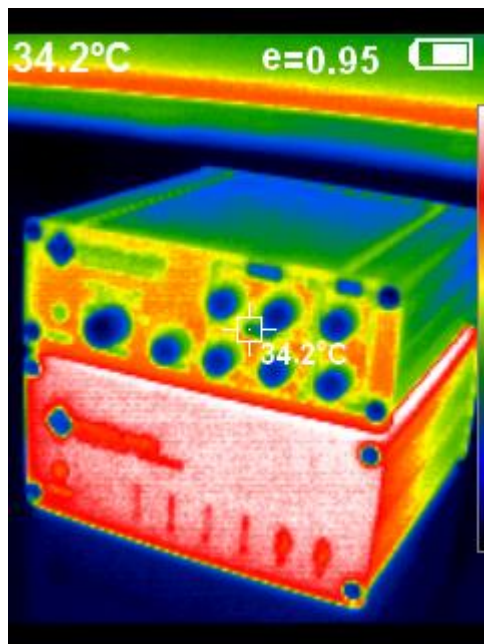
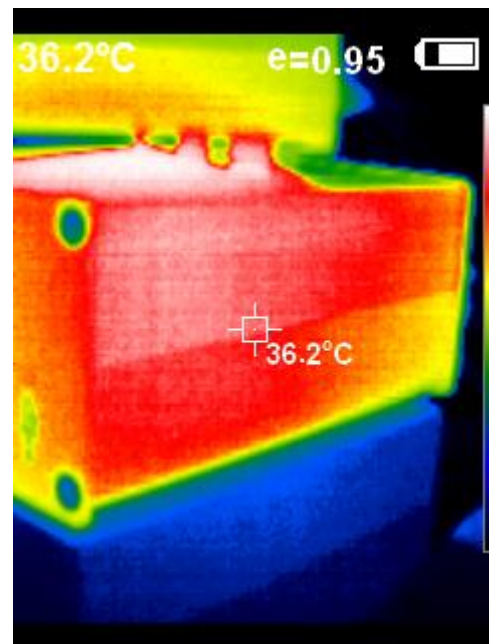
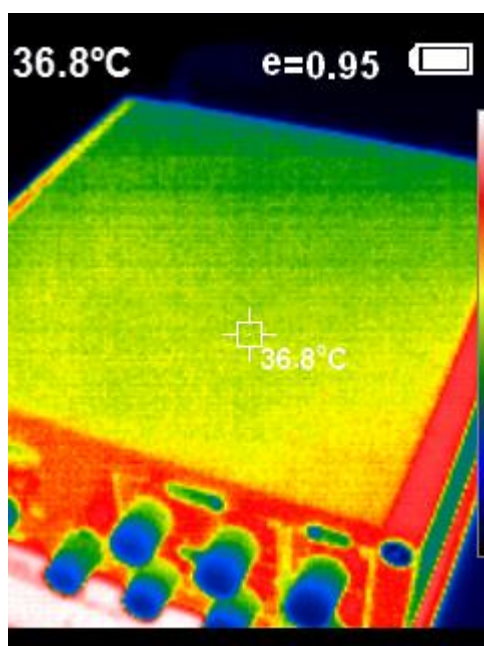
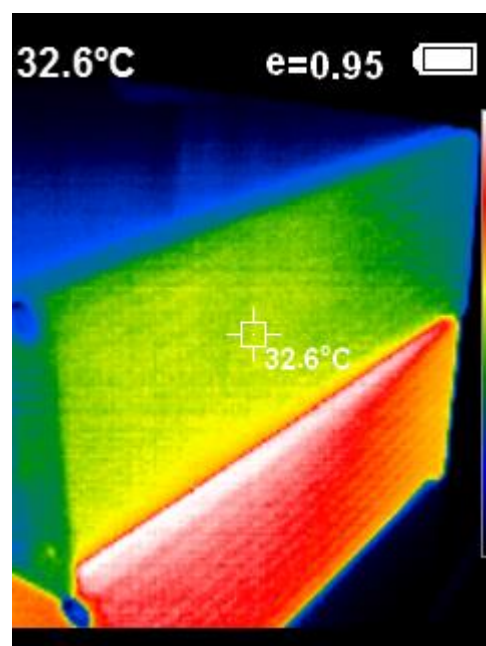
Measurements were made using an industrial thermal camera with real-time temperature tracking.

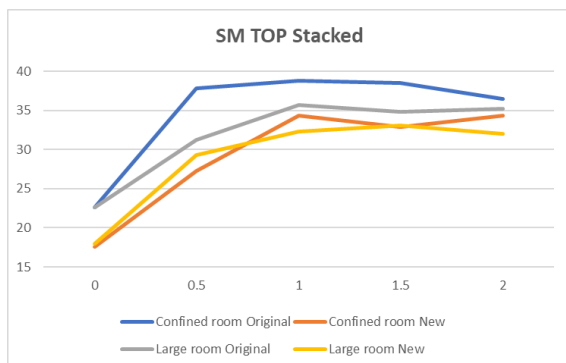
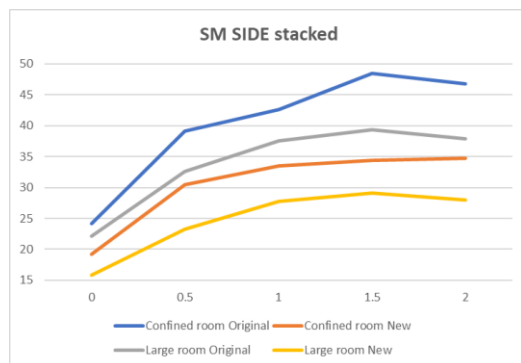
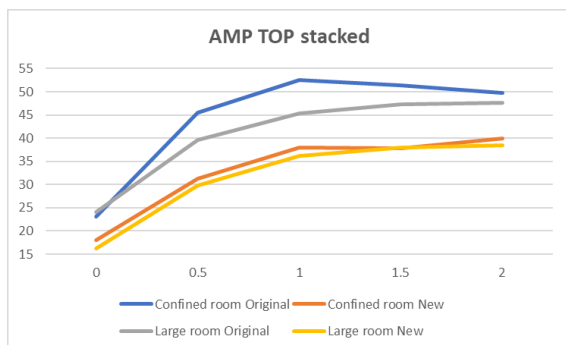
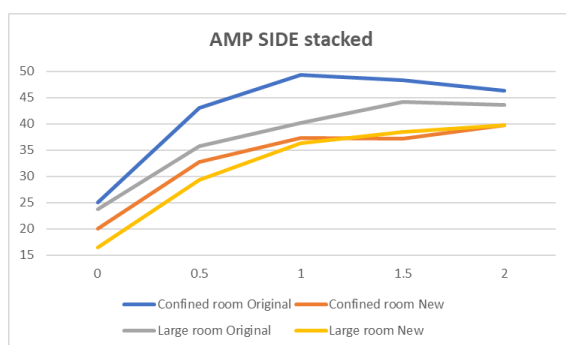
The graph results of the test matrix show a fairly clear trend, regardless of the location or physical configuration. The temperatures are in degrees Celsius and the time scale is in hours.

Stacked configuration (SMV3 sitting on top of Amp)

Regardless of physical configuration the new case is giving an overall drop of around 5 degrees Celsius on the SM and up to 10 degrees Celsius on the amp.

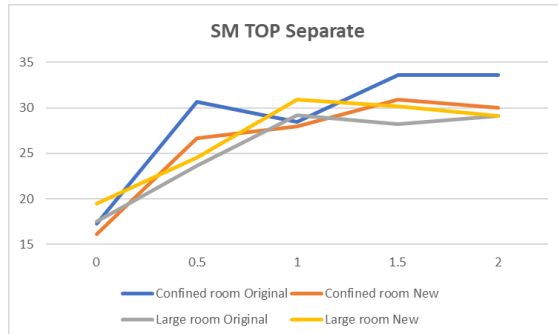
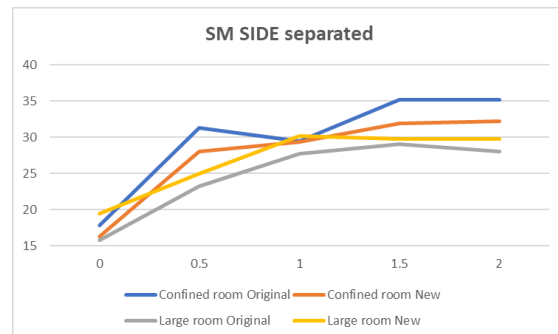
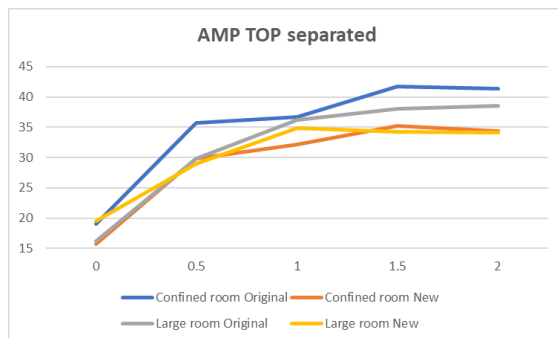
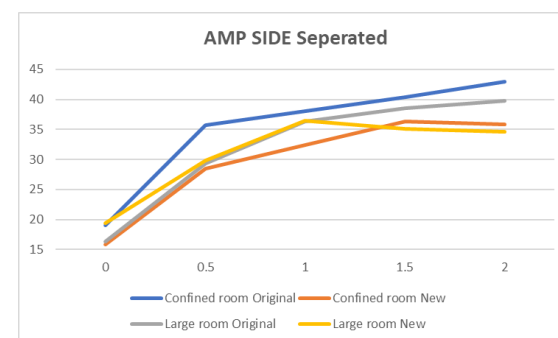
Separate configuration (SMV3 sitting next to but not close to Amp):

The amp does have the added benefit of having had the boards redesigned to allow an airflow path around the boards, and the rear of the new amp case has slotting for better air venting as well. It is also a larger case. However, it is also generating a lot more heat, so the difference in the drop in temperature shows a clear benefit of all the changes made to that unit.

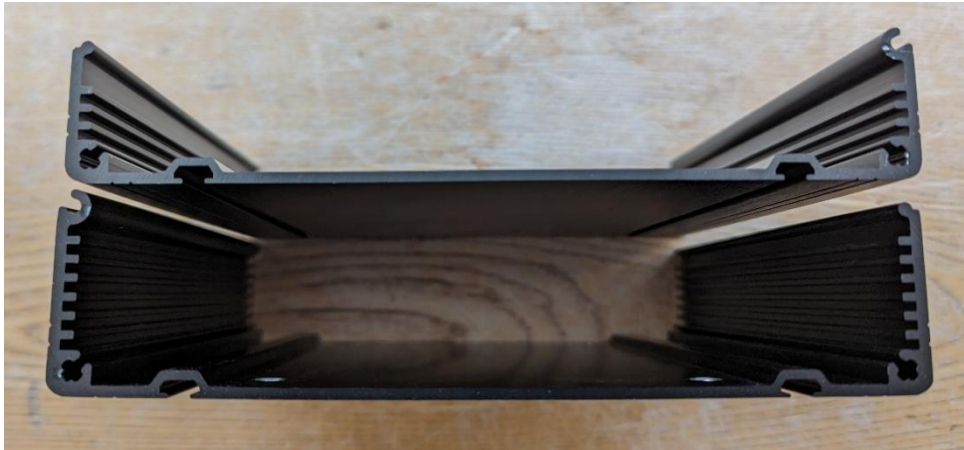
The two new extrusions, small (top) and large (bottom)

After significant revisions and concepts, we landed on the design philosophy of having two extrusions halves that could interlock, with two different sizes. This would allow us to have up to three different size configurations (small+small, small+large, large+large), giving us a range of sizes for current and potential products that would allow adapting for different thermal profile requirements, while still retaining a coherent design philosophy across all products. This also gave us other advantages, including the ability to customise the internal structure of the cases to maximise the reliability of the fitment between the electronics and the mechanics, and the airflow, as well as other smaller benefits such as more reliable case feet. The initial case had self-adhesive feet, and the heat generated from those units was enough to melt the glue and cause the feet to shift around on the base.

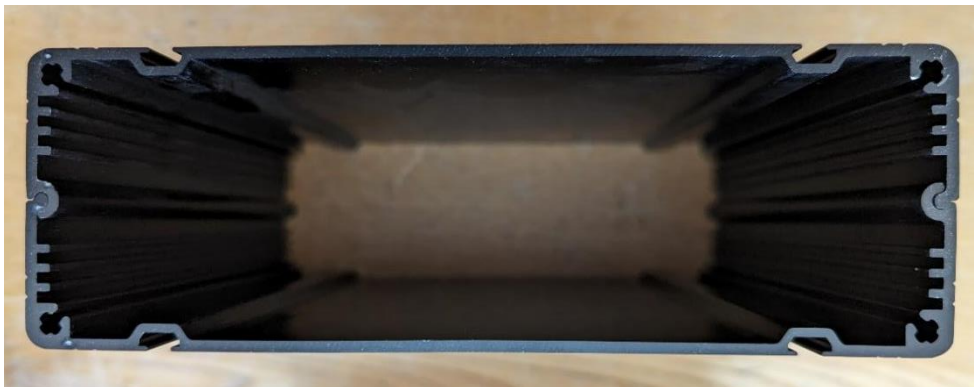
New Extruded case – SMV3 configuration (2x small extrusions)

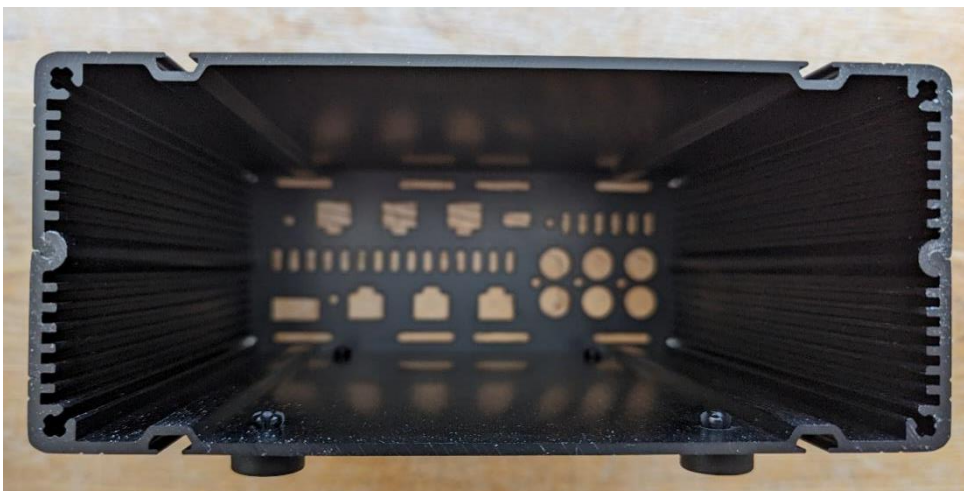
New Extruded case – AMP configuration (2 x large extrusions)

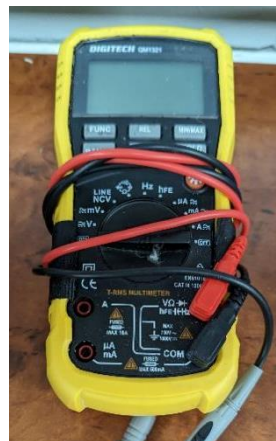
The speaker panel voltages were measured using a standard multimeter. As the voltages being measured are usually in the range of kV, high-voltage probes were required to protect the equipment. It was also used to test continuity around the outside of the panel, conductivity across the resist coating, and to test for short circuits throughout.

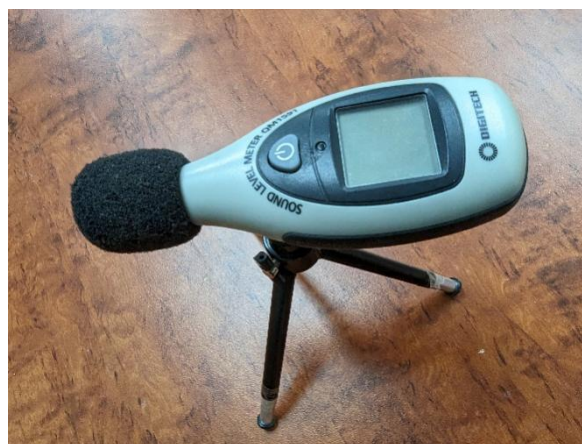
A standard SPL meter was employed, measuring the SPL of the speakers at 1Khz, at 1 meter, as per industry standard. A quiet room with minimal reflections was necessary for accurate measurements.

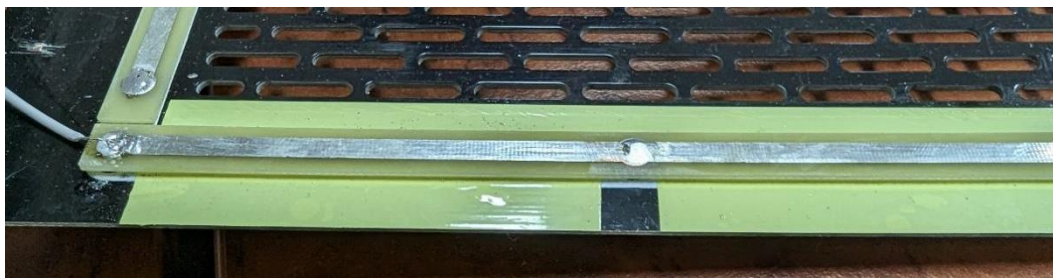
Example of strip lifting as a result of poor gluing processes and practices (seen at left)

A number of panels were shown to either have too little glue applied, resulting in mechanical failure of the side-strips, or too much glue applied or applied unevenly, leading to large amounts of glue “bloom” which leaves a lot of residues behind – this is a contaminant but also has an unappealing visual component that may end up being visible to the consumer.

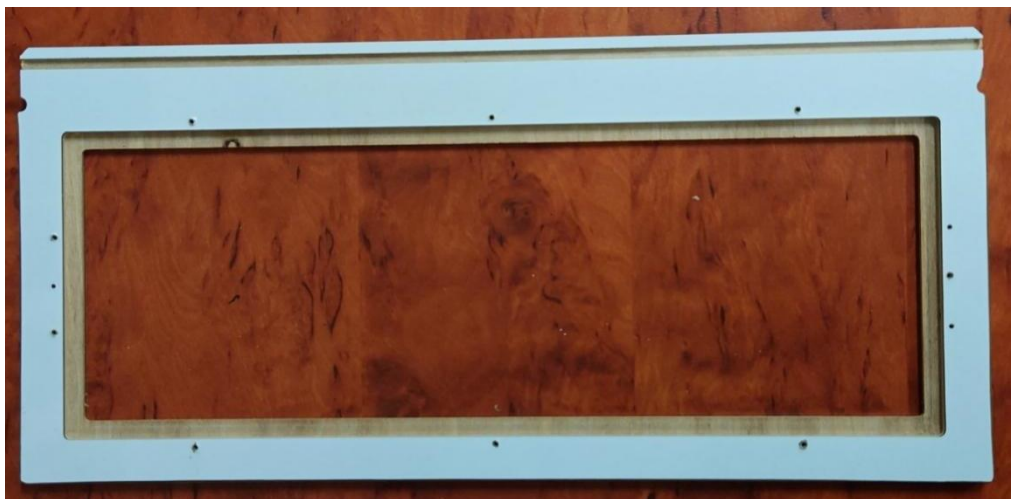
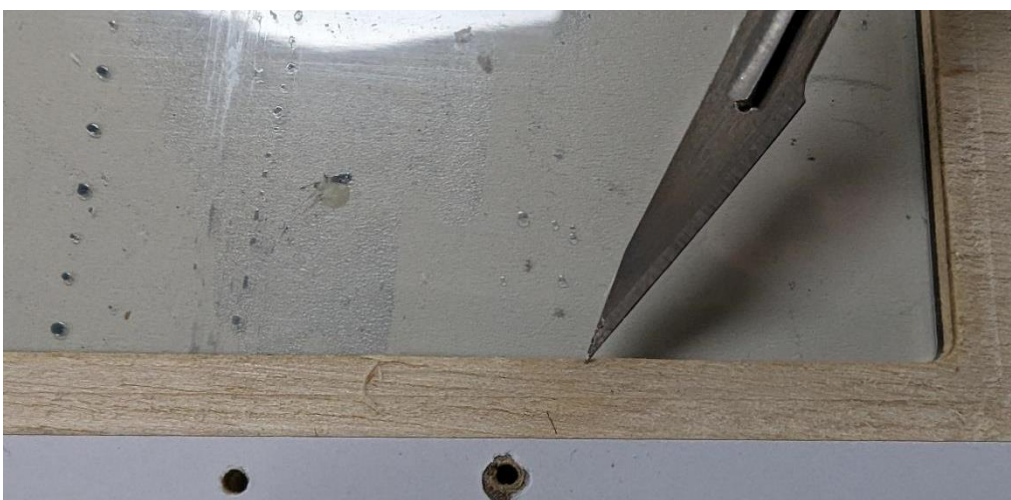
However, the change to wood introduced a path for voltage creep and more access for the environment to reach the electrical parts of the speaker. This can be seen below.

Wood frame with organic path to connector

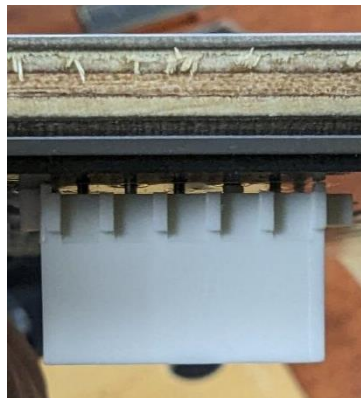
Investigation showed that a large surface area of the terminals was exposed to the environment, not in small part due to stand-offs that raise the connector above the PCB as shown below.

Terminal connections – exposed to open air underneath the connector.

To further confirm this, humid air was introduced directly at the terminals of known good panels, and the SPL immediately dropped. After drying, the sound level returned. Other panels that had degraded were heated in an oven at 80 degrees C for a few hours and the SPL on these previously degraded panels recovered significantly as well.

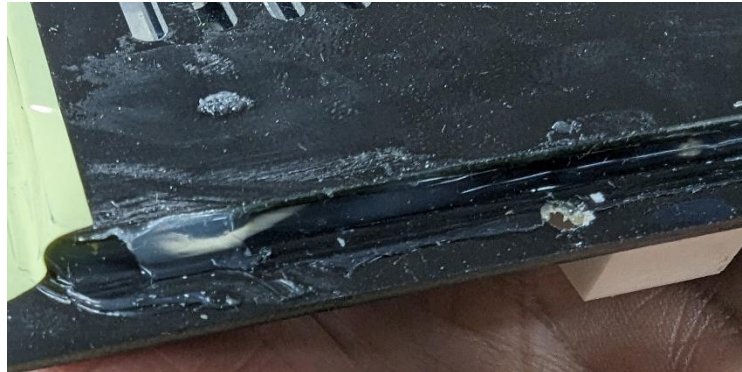
- 1) The application of silicone-based sealant to the exposed surface of the wood. This creates a waterproof seal on the absorbent and organic fibres at the point where the speaker panel interfaces with the frame.
- 2) The application of a silicone-based sealant around the exposed edges of the speaker panel.

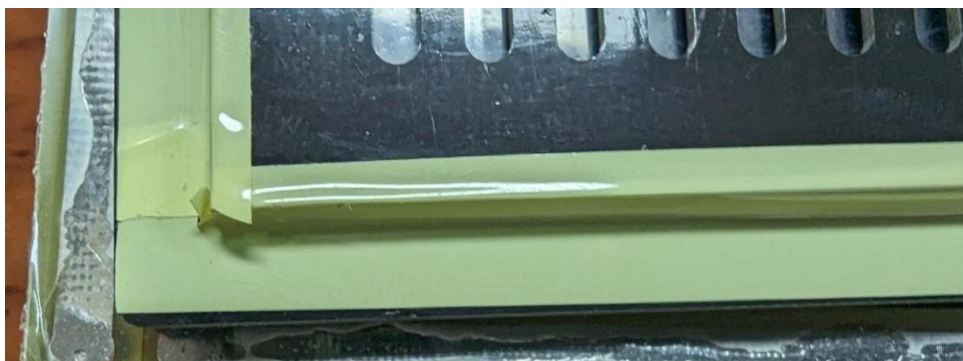
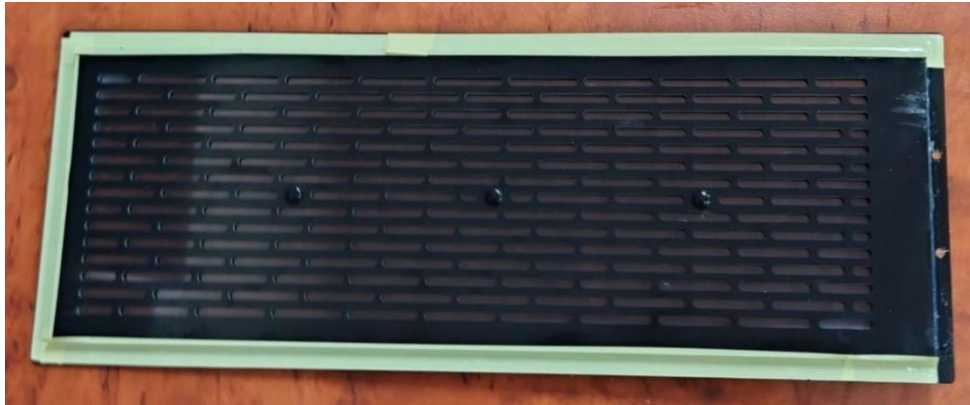
- 3) The application of high-voltage-resist tape around the edges of the speaker panel

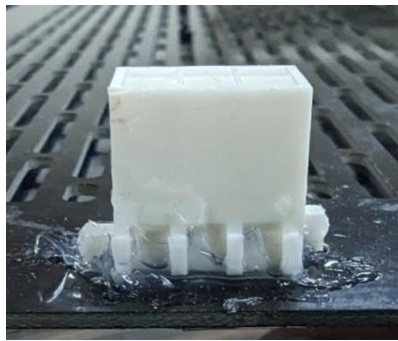
- 4) The application of silicone-based sealant around the connector interface, and:
- 5) The removal of stand-off tabs on the connector interface to reduce the exposed surface-area of the conductors.

These steps effectively create multiple electrical and environmental seals at various points in the entire panel structure, sealing the electrical interfaces of the panels from the environment.

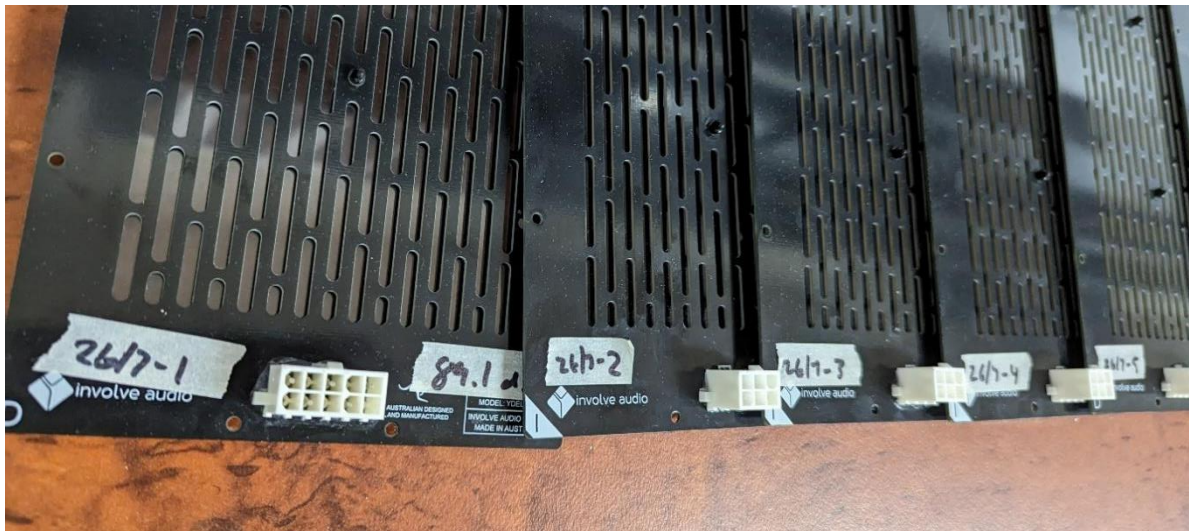
Even after all the solutions were implemented, there was still variations to the SPL output of the panels. This variation is only in the order of a few dB however. The proposed solution is to measure the capability of every manufactured panel and ensure that matched sets are created for each product so that the listening experience is as consistent as possible.

Example of panels that are marked with their SPL for matching.
