Rifle Design: American made, mass produced Hawken style, percussion patent breech.

Location, Date: Indiana, March, 1986

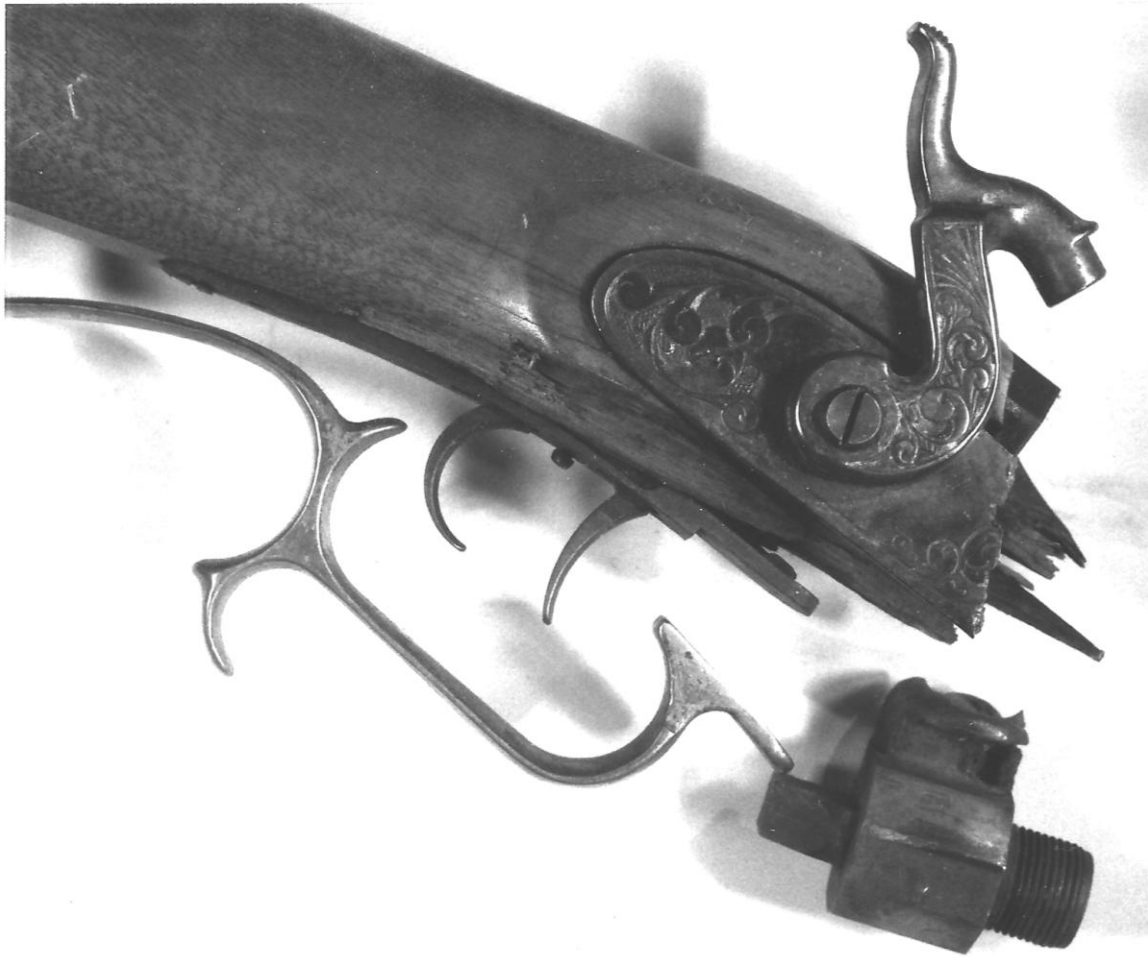
Nature of Failure: Barrel, lockplate and stock destroyed. I believe those few shots with Unique so weakened the metal (started cracks), and that is why it finally burst with a black powder load.

This is the result of firing just a few rounds with smokeless powder

Background: The fouling and a few grains of FFG black stuck in the breech indicate that this rifle was indeed loaded with black powder when it burst.
